Phungela TT, Maphanga T, Chidi BS, Madonsela BS, Shale K. The impact of wastewater treatment effluent on Crocodile River quality in Ehlanzeni District, Mpumalanga Province, South Africa. *S Afr J Sci.* 2022;118(7/8), Art. #12575. <https://doi.org/10.17159/sajs.2022/12575>

The impact of wastewater treatment effluent on Crocodile River quality in Ehlanzeni District, Mpumalanga Province, South Africa

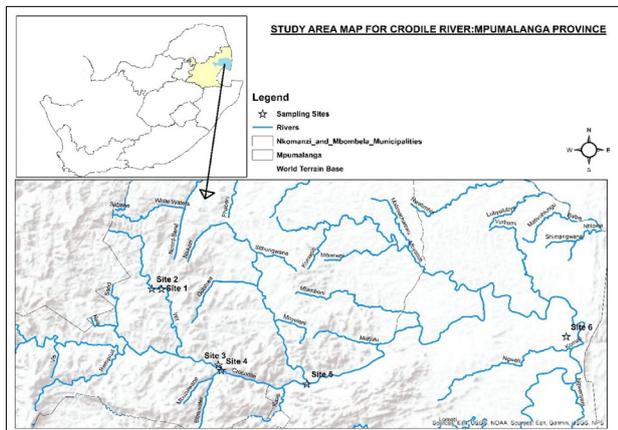
Figure 1: Map of the study area showing the location of sampling points.

Samples were collected from six sampling sites located in the study area within Mbombela Local Municipality and Nkomazi Local Municipality, which included three WWTPs discharging effluent into the Crocodile River. Within the river, a total of 108 samples were collected between 2017 and 2019. Table 1 lists the sampling sites and their coordinates.

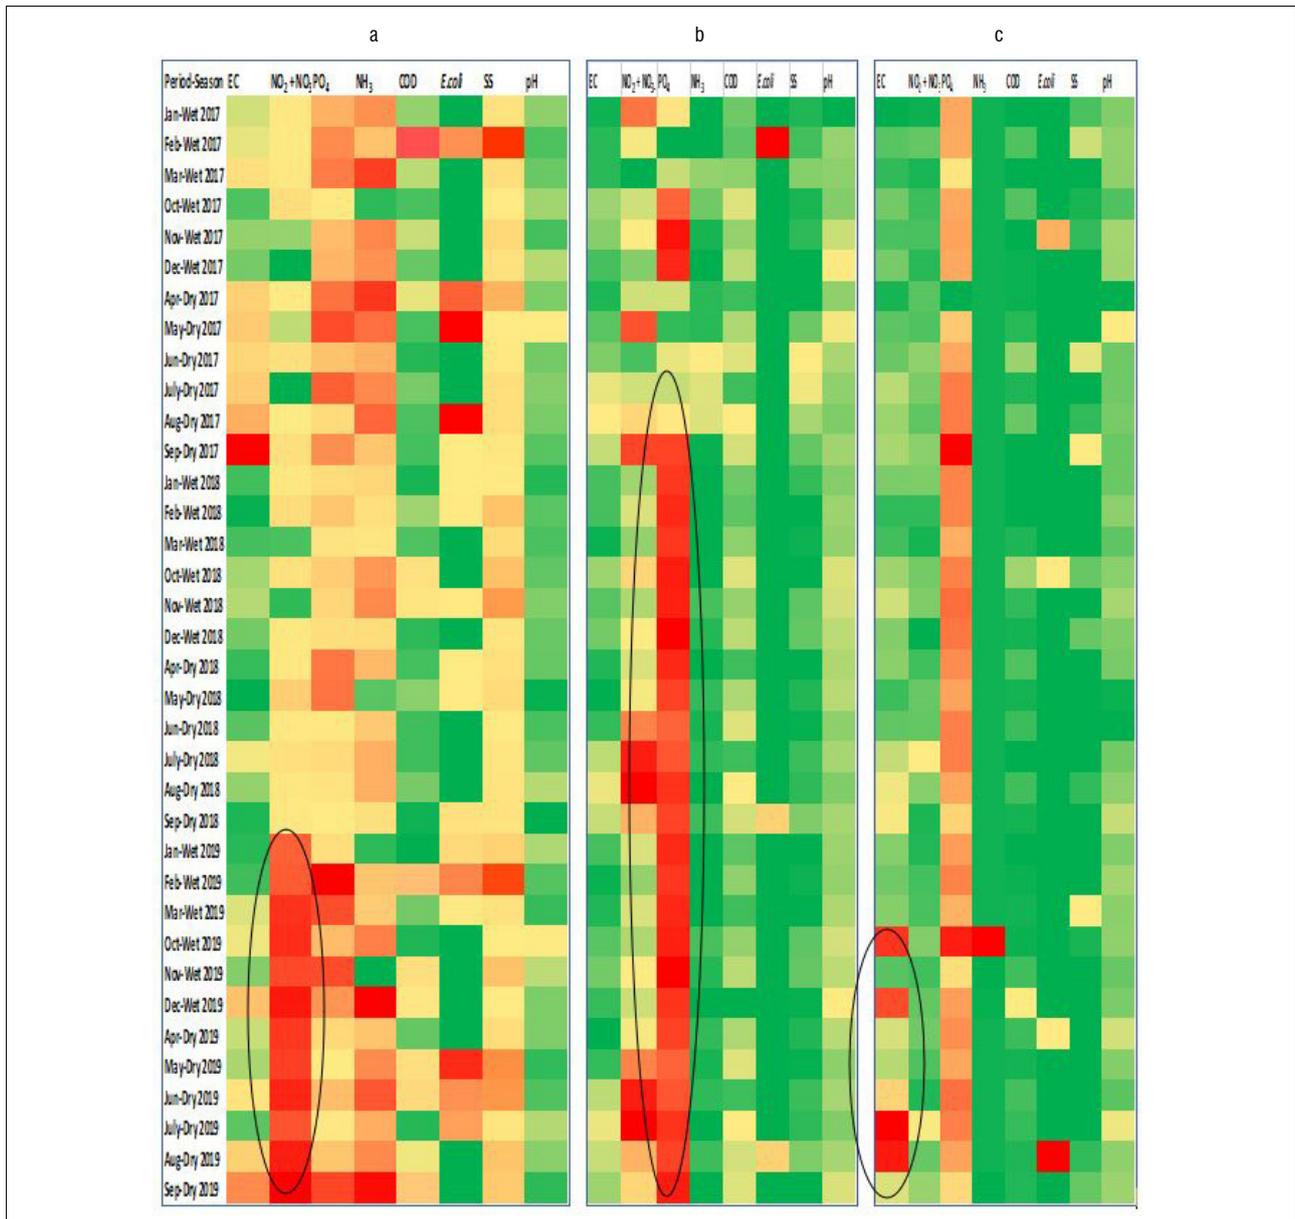
Figure 2: Heat maps showing variations in water quality parameters for (a) White River wastewater treatment plant (WWTP) Site 1, (b) Khanyamazane WWTP Site 3 and (c) Matsulu WWTP Site 5. The higher the intensity of the red colour, the higher the measured parameter. The higher the intensity of the green colour, the lower the measured parameter.

The heat maps allowed us to explore large data sets and visualise important cases or clusters. Figure 2 depicts changes in water quality indicators analysed per sample location from 2017 to 2019 over two separate seasons (dry and wet). For each parameter studied, data were categorised and compared based on time and season. The actual numerical values are shown in the supplementary material. Water quality data were compared by season (dry and wet) because rainfall run-off has a major influence on the quality of a water resource and the quality of discharged effluent, as well as acting as a diluting factor on the overall concentration of waste.²³

The water body receiving treated effluent from wastewater treatment around the White River WWTP (Site 1) had a wide range of pathogenic microorganisms. In particular, the region got a significant amount of ammonia (NH_3) in 2017 when compared to the other locations (Sites 3 and 5) in the same year. The levels of ammonia were above the legal limit which is set for White River WWTP as per the effluent discharge quality limits for the WWTP water use licence within that area (Table 3). High levels of nitrate (NO_3) and nitrite (NO_2) were observed from Site 1 in the 2019 wet season. WWTP effluent had a considerable impact on ammonium and nitrate concentrations in the water which means that a post-treatment may be required for removal of nitrate,

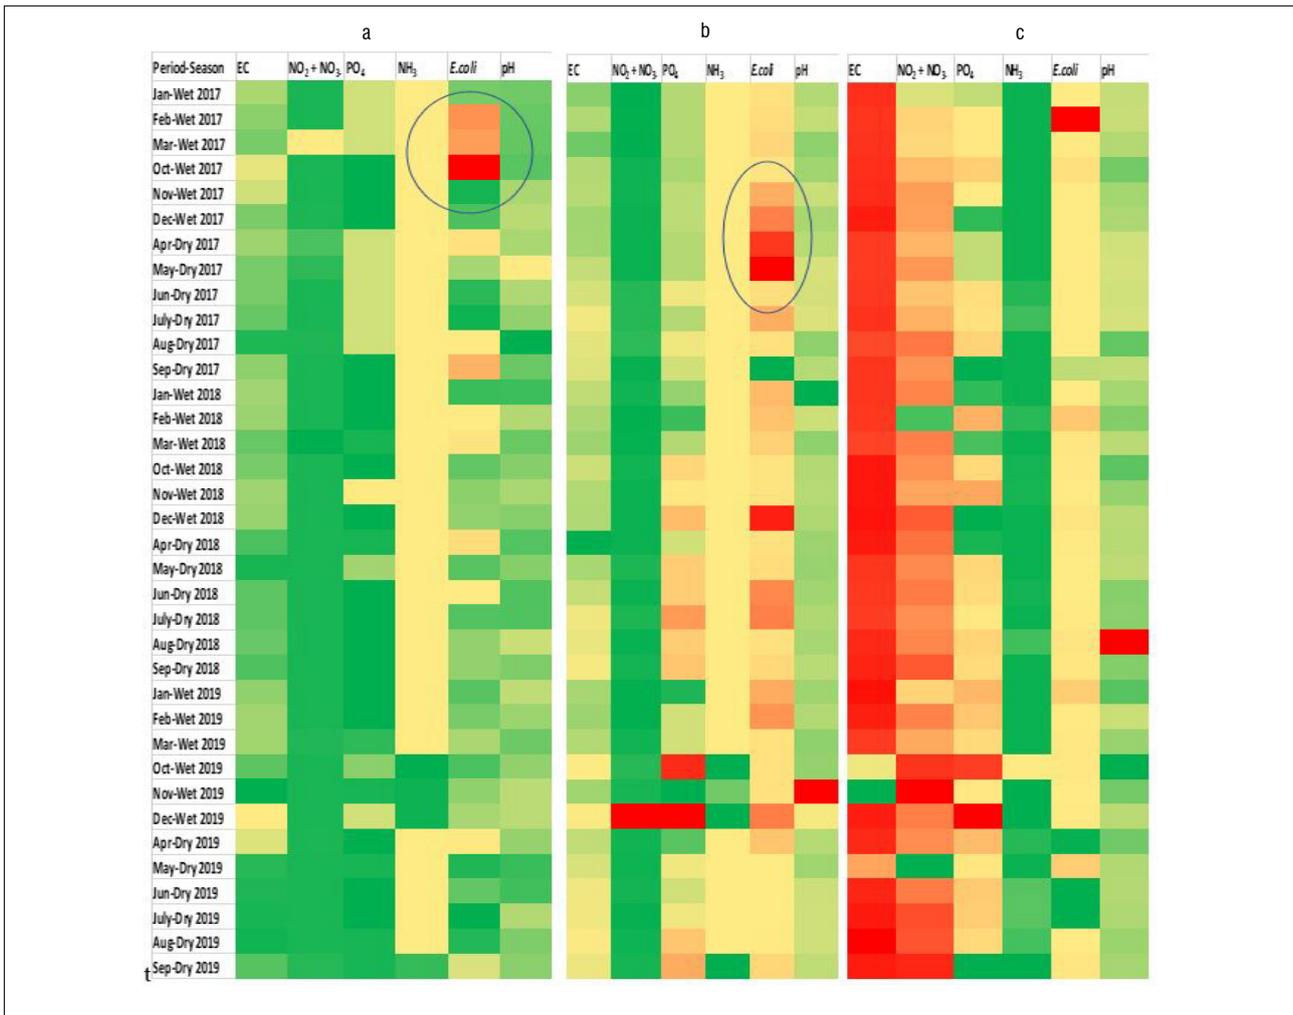
Figure 3: Heat maps showing variations in water quality parameters for (a) White River – Crocodile River (Site 2), (b) Kanyamazane N4 Bridge (Site 4) and (c) downstream Komatipoort wastewater treatment plant (Site 6). The higher the intensity of the red colour, the higher the measured parameter. The higher the intensity of the green colour, the lower the measured parameter.

Figure 3 shows heat maps depicting changes in water quality parameters analysed per sampling site (Sites 2, 4 and 6) in the Crocodile River. Water quality data were compared according to seasons (dry and wet) because rainfall run-off has a significant impact on the quality of a water resource. For each parameter studied, data were categorised and compared based on time and season. Two parameters – namely chemical oxygen demand and suspended solids – which were analysed

Figure 3 shows heat maps for Site 2, Site 4 and Site 6 analysed for visualisations of the results obtained in the Crocodile River. Parameters from all three sites were compared to the standard set by the Department of Water Affairs as per Government Gazette no. 39614 and issued water use licences to check if they complied with the set standards. Site 1 is a confluence point between White River and Crocodile River, and the area is mostly dominated by agricultural land-use activities. Data revealed that water resource quality at this site was compliant with the set limits for parameters outlined in the resource quality objectives in most months (Table 4). Although Site 2 was compliant with the set limits, in the 2017 wet season, it recorded values above the legal limits. The site is situated downstream of the White River WWTP, and so it was expected that, as the effluent from the WWTP had high *E. coli* counts during 2017 and 2019 of the same periods, this site would exhibit higher *E. coli* counts during these months; however, higher *E. coli* counts were noted in 2017 only. It was also noted that the area received minimal rainfall of between 100 mm and 200 mm between April and May 2019. These results contradict those of Abia et al.³⁰ who outlined that run-off from the storm influenced the concentration of *E. coli* in the water resource because run-off carries sediments containing microorganisms into the river.
